URBANIZATIONAL CHALLENGES IN UTTARAKHAND STATE: A CASE STUDY

Ms. Swati S. Nibhorkar

S. B. Jain Institute of Technology Management and Research Nagpur
swatinibhorkar12@gmail.com/ swati.nibhorkar@sbjit.edu.in

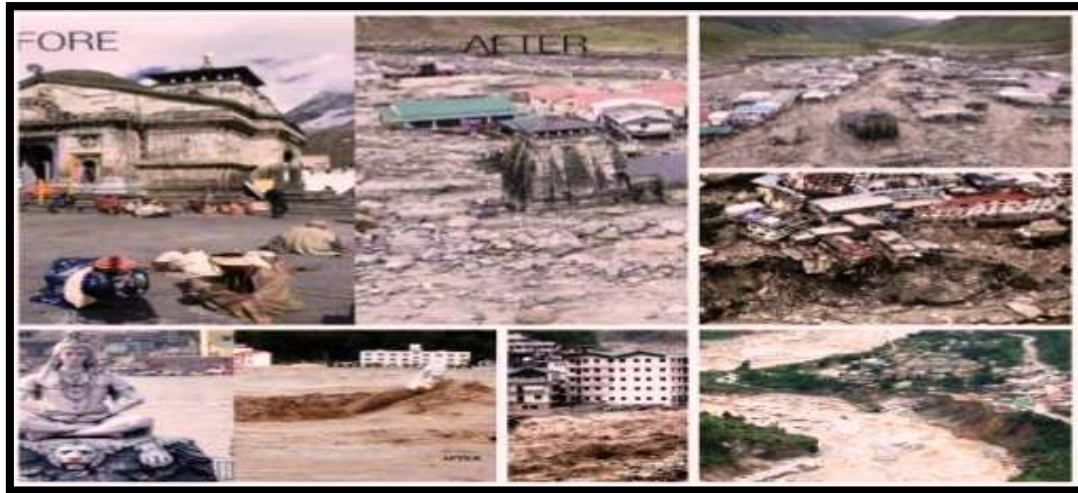
Ganga and Yamuna are the most important rivers originating from the glaciers of Uttarakhand. Uttarakhand region has a past history of heavy rainfall. In June 2013 a multi-day cloudburst centered on Uttarakhand, caused a devastating floods and landslides. It became country's worst natural disaster after the 2004 Tsunami. Prediction of the natural disaster is difficult. Lack of knowledge, improper planning and supervision of infrastructure, increases the severity of disaster. Figure1 shows the different damages occurred in Uttarakhand state in June 2013.

Figure 1: Uttarakhand Tragedy in June 2013 (www. Disasterphotos.com)

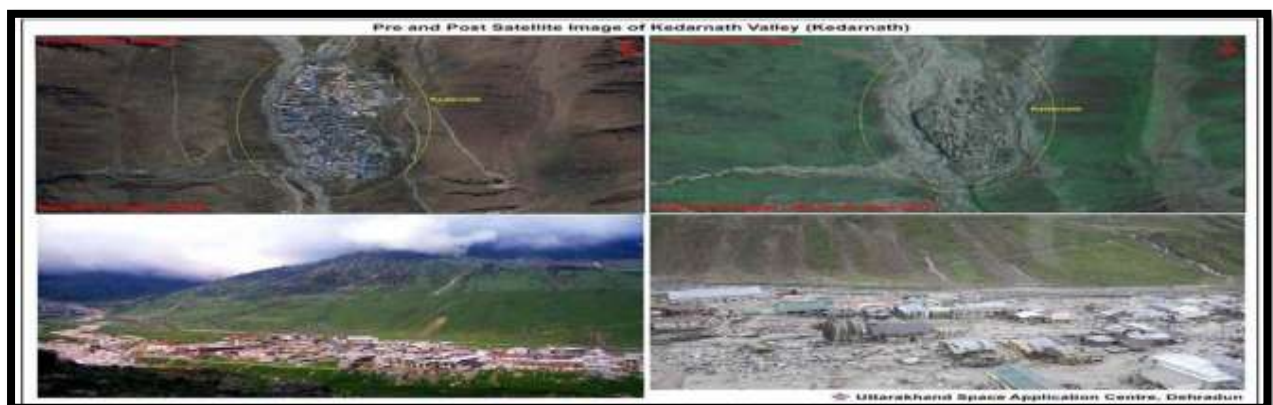
National Remote Sensing Centre (NRSC) scientist of ISRO analyzed that due to geophysical structure of this area, it is more prone to disaster. In Kedarnath temple region on 14 to 16 June 2013, large scale debris carried by the huge volume of water from upper reaches above the town. One of the compounding factors was that the glacial regions above the Kedarnath had received fresh and excess snowfall, when heavy rainfall hit the region, rainwater with higher temperature falling on the snow must have led to heavy snow melt and this runoff would have added to the rainwater runoff, resulting in huge water flow that carried with huge debris flow which struck the town with massive intensity. According to NRSC scientists, the detailed dynamics of water flow due to snow melt caused by rain, mostly when snowfall is in excess and the hydrology of it is not well understood. Figure 2 shows that the images before and after disaster. Landslide and flow of debris is visible.

Figure 2: Pre & Post Satellite Images of Kedarnath Area

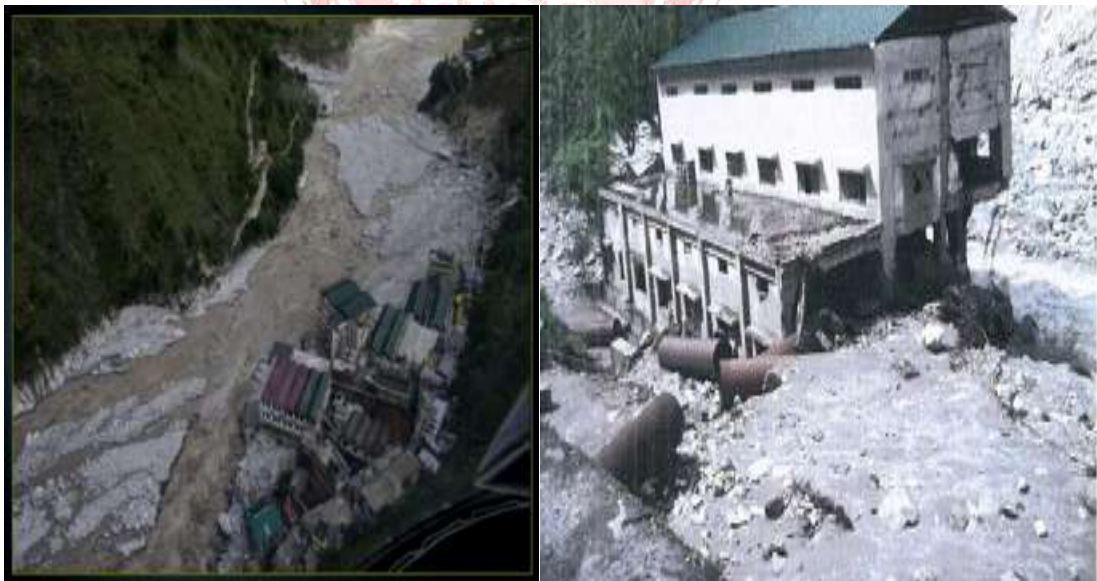
1. Two hotels were washed away i.e. Bedubagad, Augustmuni
2. Silli and Chandrapuri region which are situated on Kedarnath national highway 140 houses were washed away and another 100 were badly damaged. Human casualties information is not available.
3. Kedarnath walk has got severely damaged. Approximately 25000 people were trapped in Kedarnath valley only.
4. In Kedarnath, unofficial reports are claiming that the entire infrastructure has got severely damaged. Even the Kedarnath temple has also been partially damaged.

Figure 3: Damages in Rudraprayag Uttarkashi:

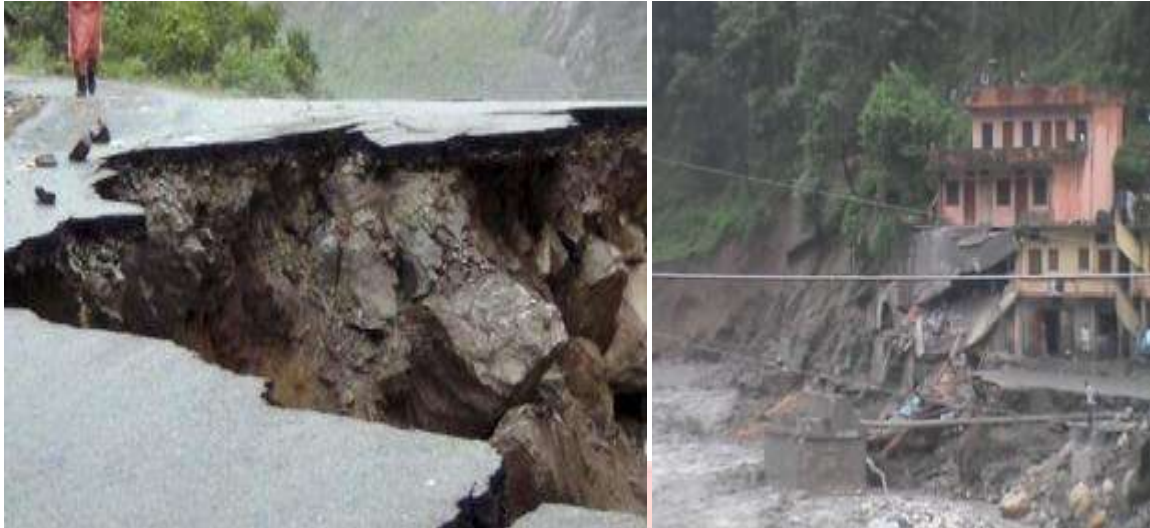
1. Due to landslides and cloudburst, there were four deaths reported in Udri village. Joshiyara and Tiloth villages were also badly damaged. As per the record total 123 houses had been completely collapsed and 22 houses had been partially damaged.
2. In Didsari village, 35 families were affected by the disaster due to damage of houses.
3. Jadau village had come under the landslide zone and the villagers evacuated their houses and are living in the temporary shelter.

4. Road network connecting Uttarkashi to Gangotri, SBMA (Shri Bhuvaneshwari Mahila Ashram) – plan working area road connectivity between Malla to Lata and Uttarkashi to Dhunda had been damaged mostly.
5. Dingla power house to Sangamchatti was damaged. Agricultural land, bridges and other village path of Dhanari area were fully washed out due to heavy rainfall.
6. Forest Department Park was in danger zone. An electricity and communication connection was lost due to disaster in most of the region.

Figure 4: Damages in Uttarkashi District

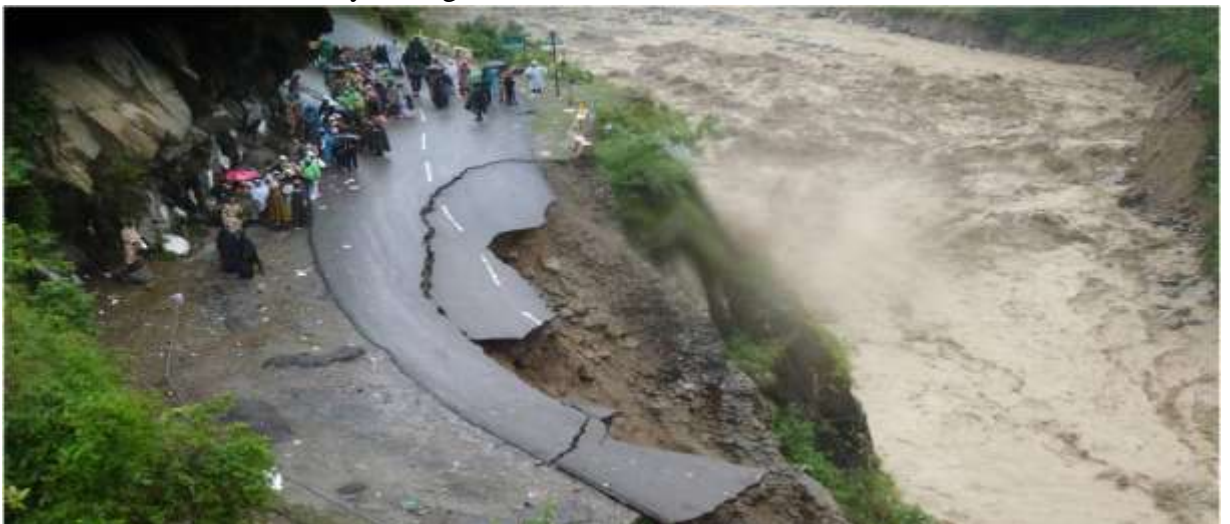
1. Four houses and Jhula Bridge was washed away in Narayan Bagar. In Tharali block around 100 m road and about 20 houses collapsed totally.
2. Bhyndar village in Badrinath valley was washed out completely. Many two wheelers and four wheelers were washed out due to disaster
3. Chamoli district was heavily damaged in June 2013 disaster.

Figure 5: Damages in Chamoli District

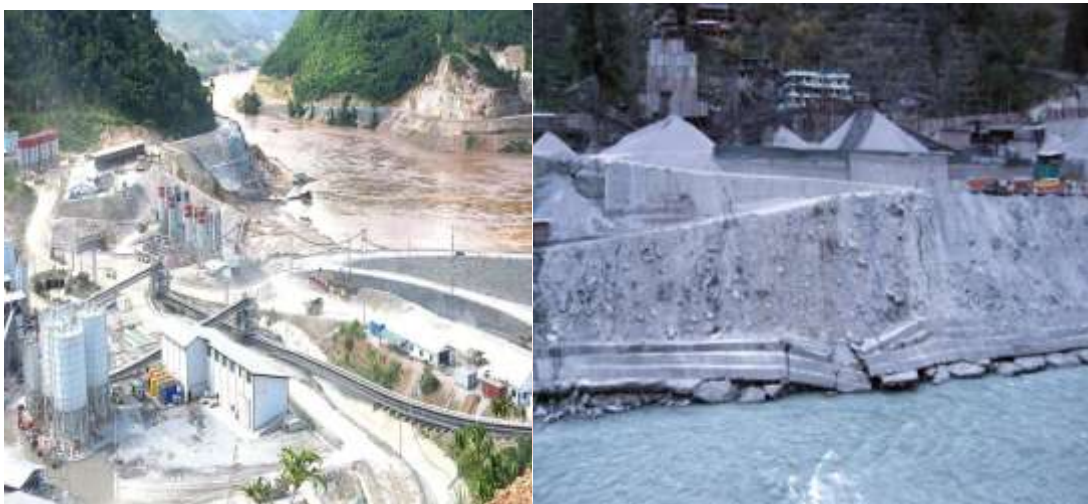
1. According to the energylineindia.com update on June 27, 2013 the 520MW under construction Tapovan Vishnugad HEP had suffered damages by disaster.
2. Construction of diversion tunnel was completed in April 2013, it was washed out due to heavy rainfall.
3. 400 MW Vishnuprayag HEP of JP associates was suffered. 99 MW Singoli Bhatwari HEP of L&T and 76 MW, Phata Bhyung HEP of Lanco in Mandakini valley in Uttarakhand were severely damaged.
4. Kali Ganga-I and Kali Ganga-II and Madhyamaheswar HEP all in Mandakini valley were severely affected by disaster and likewise many hydropower projects were damaged due to disaster in Uttarakhand State.

Figure 6: Damages in Hydro Power Project

If the construction of dams or roads is not in a proper manner then it increases the severity of disaster. To minimize an intensity of disaster it is important to design dams, bridges, roads and hydropower project according to disaster resistance design. IS 1893-2002 is revised now in 2016, so it is important to consider new clauses in design and retrofitting of the existing structure according to revised code.
