STRUCTURAL HEALTH MONITORING OF REINFORCED CEMENT CONCRETE STRUCTURE USING NDT TECHNIQUES

Case study 1- Structural Health Monitoring of RCC ESR at Nimbhi

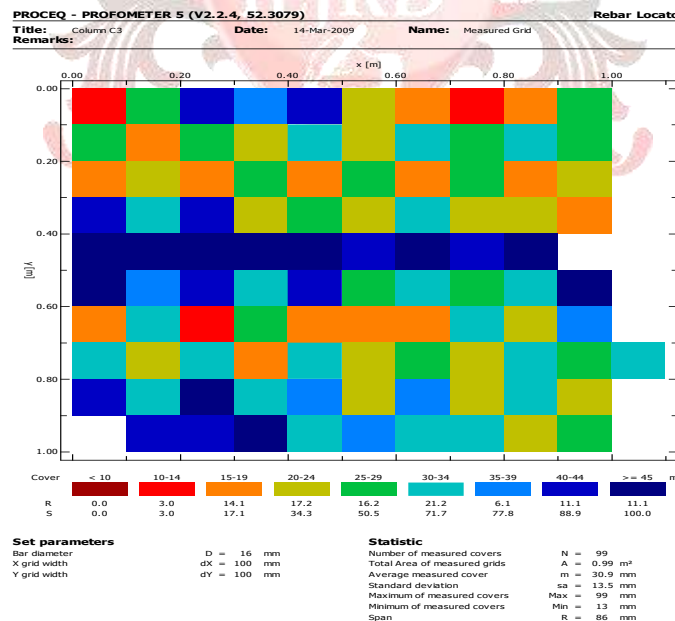
Fig. 7 Variation in concrete of cover column C3

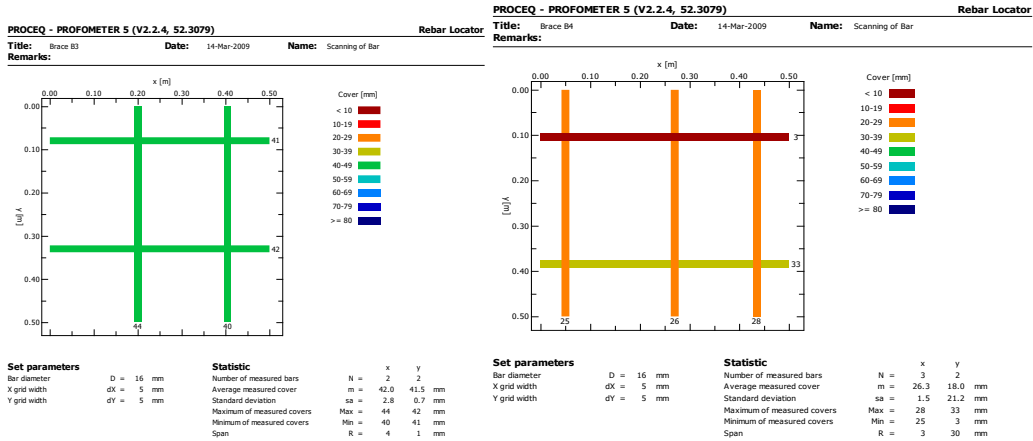
Fig. 8 Details of reinforcement in brace beam B3 & B4

- The profometer rebar locator test on Brace B4 gives average concrete cover along X -direction 26.3 mm and along Y -direction 18mm. This cover is poor as an actual requirement.

- The profometer rebar locator test on Brace B3 gives average concrete cover along X- direction 42.0 mm and along Y- direction 41.5 mm. This cover is sufficient as an actual requirement.

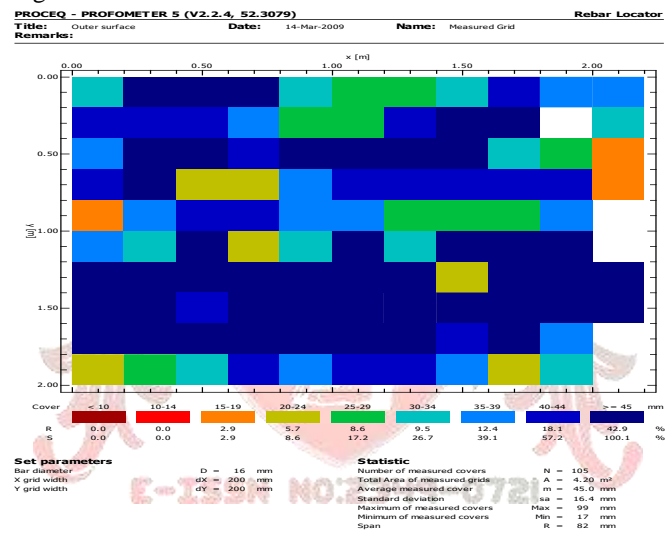
Fig. 13 Variation in concrete of cover water tank container

- j) The profometer rebar locator test on Water tank container measured with grid gives average concrete cover of 45.0 mm. This cover is sufficient than actual requirement.

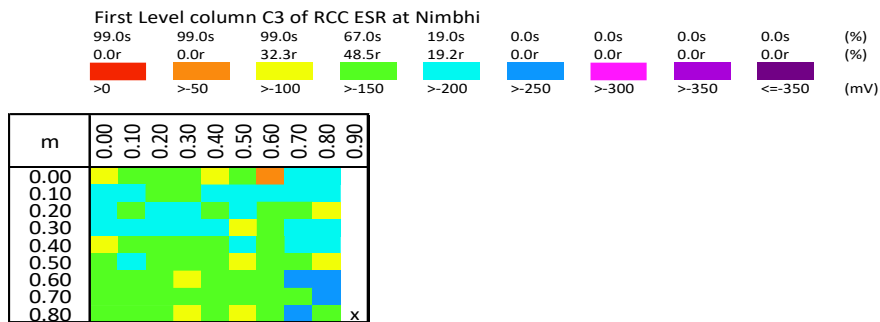
Fig. 21 Corrosion mapping of first level column C3
Table 9 Interpretation of corrosion mapping of Column C3

Electric potential	No of Reading (in %)	Corrosion activity
Less than -200 mV	47%	90% probability of no corrosion
-200 to -350 mV	53%	50% probability of corrosion
More than -350 mV	0%	95% probability of corrosion

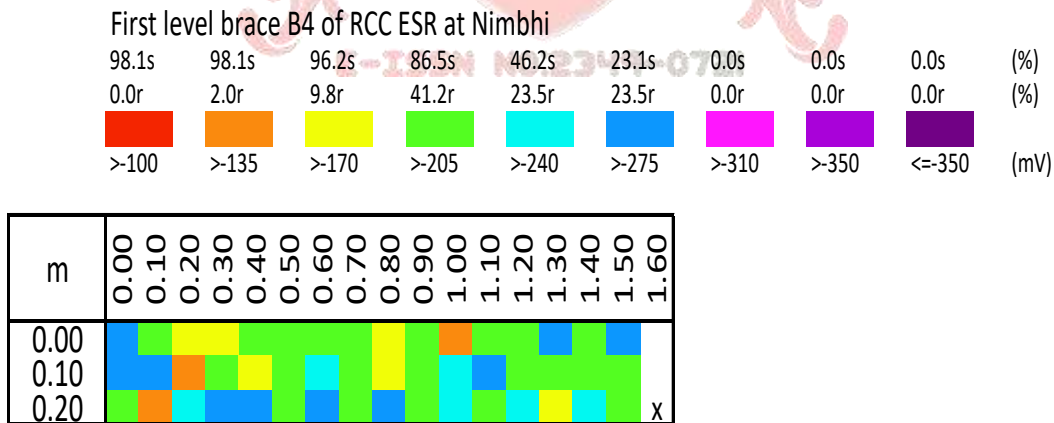
Fig. 21 Corrosion mapping of first level brace B4
Table 10 Interpretation of corrosion mapping of brace B4

Electric potential	No of Reading (in %)	Corrosion activity
Less than -200 mV	57%	90% probability of no corrosion
-200 to -350 mV	43%	50% probability of corrosion
More than -350 mV	0%	95% probability of corrosion
